Essex County Council Flood Investigation Report

Thaxted
Uttlesford District

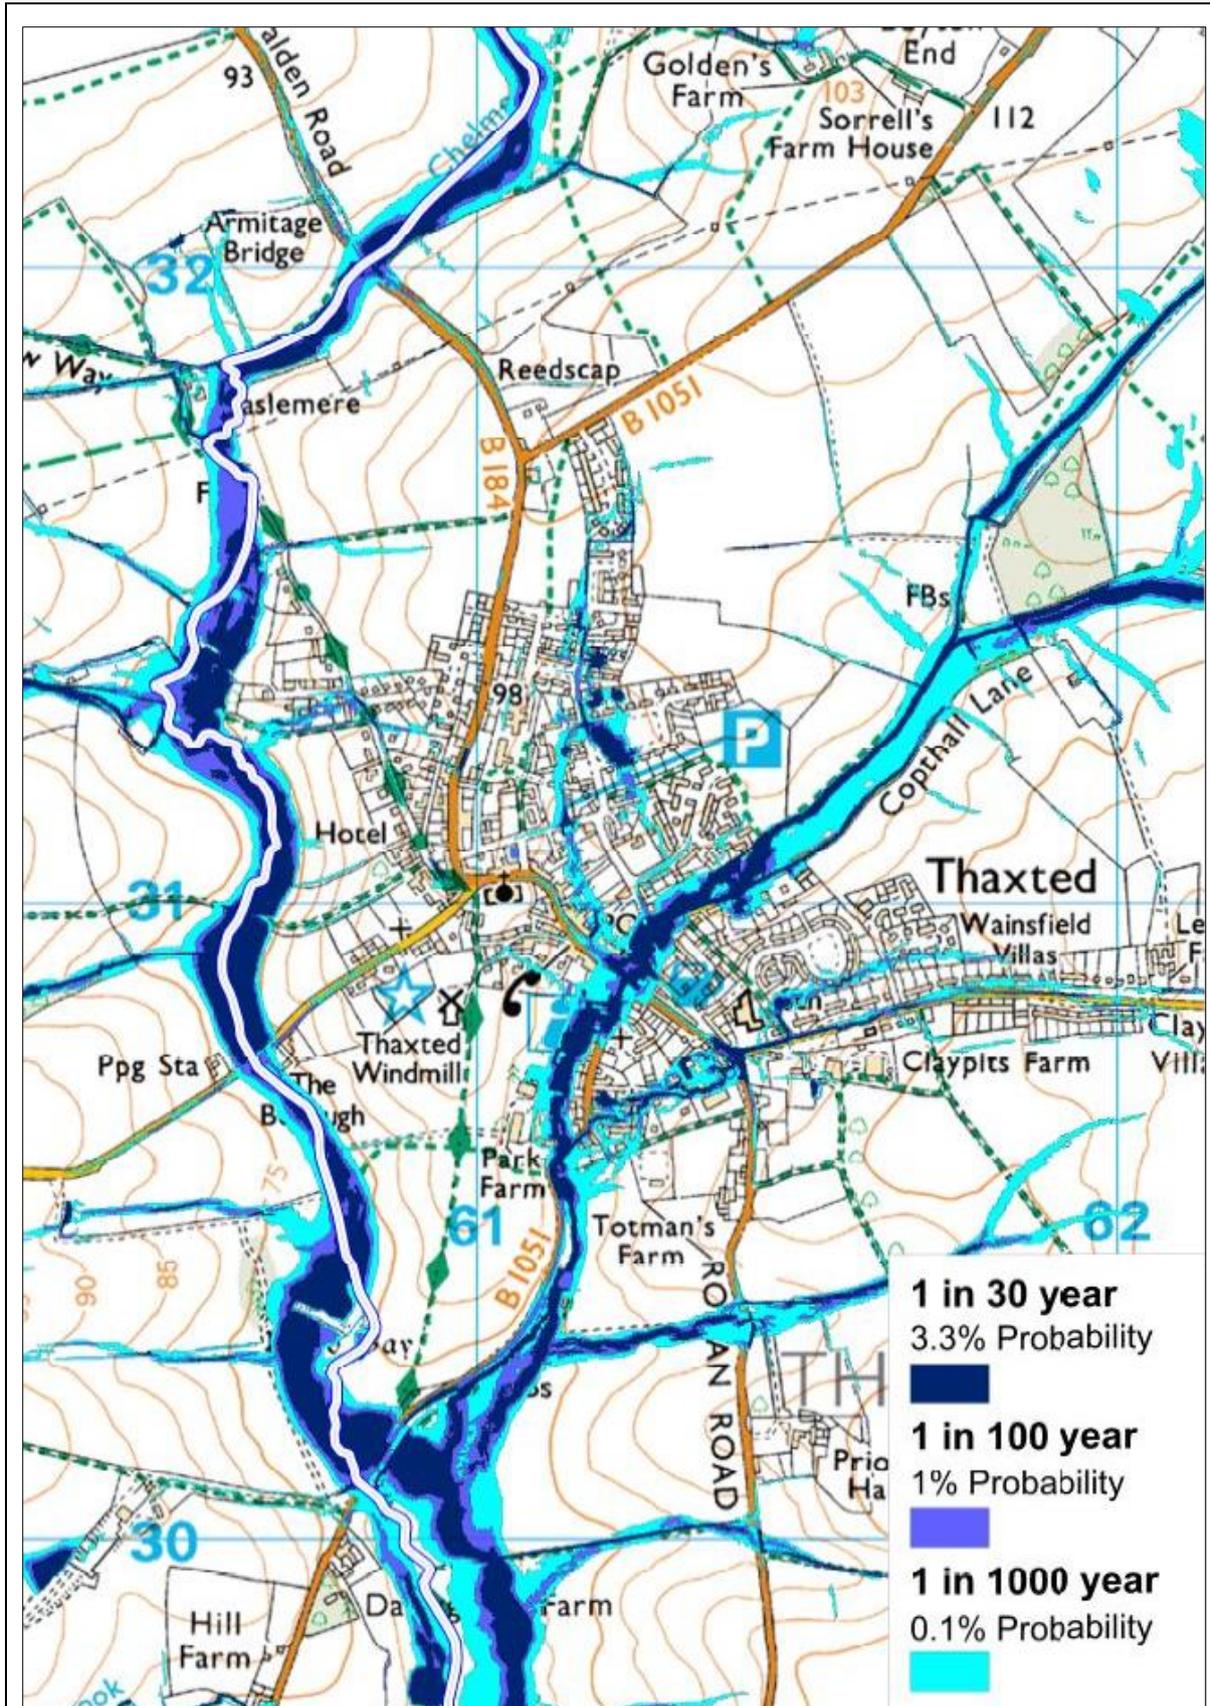
Figure 2 shows the updated Flood Map for Surface Water (uFMfSW). As is demonstrated on the map, Thaxted exhibits a high level of susceptibility to surface water flooding, with some areas predicted to flood in a 1 in 30 year event or greater (3.3% probability of occurring any given year). The flood depth in some of the locations during this event is predicted to be in excess of 900mm.

There are three main flow paths of significant flood risk shown in Figure 2, in addition to the flood risk associated with the main river to the west of the map. The first area is related to an open watercourse running from the north of the town, south of the B1051, which then continues south towards the centre of the town. There is also an additional flow path running east to west, then a main open watercourse which runs from north east of the town. The detailed drainage network is shown in Figure 4.

The locations of the highest risk areas for surface water flooding shown on the map demonstrate that the town is situated on a significant natural drainage path towards the River Chelmer (shown in white on Figure 2). This means that historically it is likely that a series of uninterrupted open watercourses would have existed, carrying flow through the present location of the town. These watercourses have since been culverted in multiple locations to allow development and the construction of roads.

Figure 2 – Updated Flood Map for Surface Water (uFMfSW), (Environment Agency, 2013; Base Map: Ordnance Survey, 2014).

Whilst the rainfall on this event was exceptional, it is clear from the evidence presented that the area does exhibit a significant level of residual flood risk. As is demonstrated in Figure 2, three separate flow paths which carry water from a large catchment area converge in the centre of the town in a system which has experienced widespread culverting to allow for development and road building. The volume of water draining through the town is substantial and is indicated by the presence of a large diameter culvert (estimated to be 1470mm) through the centre of the town. Whilst this culvert is very large the culverting of watercourses commonly causes a loss of capacity and increases the likelihood of blockages occurring. Therefore the presence of a culvert is more likely to create a constriction on flow and cause flow to back up in open sections, increasing flood risk. As such, many areas in the town are predicted to be at risk of surface water flooding in a 1 in 30 year flood event (3.3% chance of occurring each given year), with flood depth exceeding 900mm in some locations.

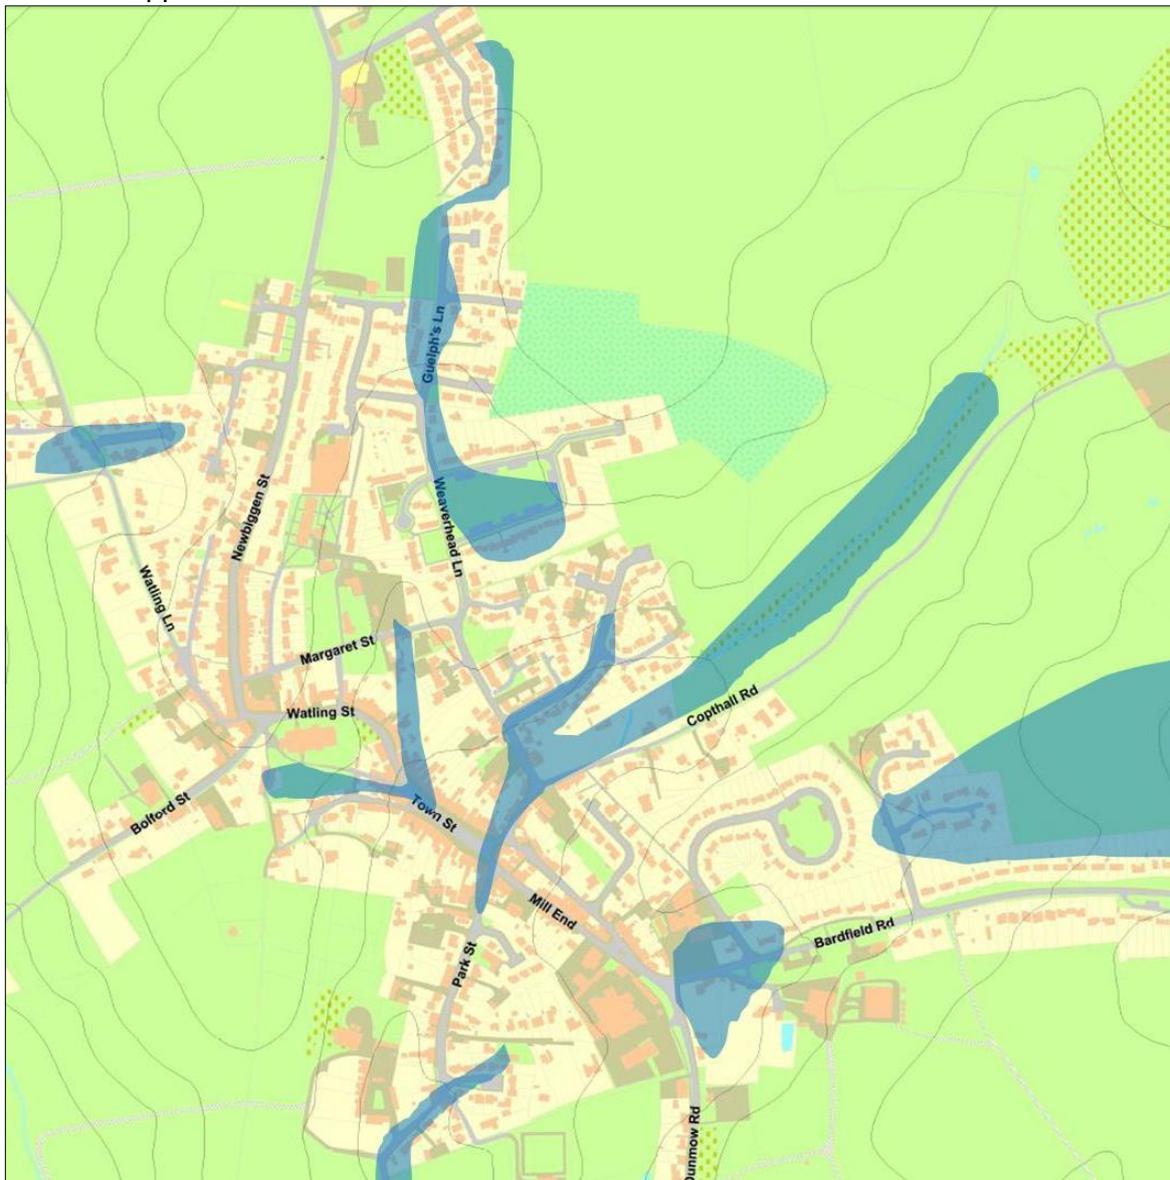
Thaxted has experienced flooding on several occasions, with the most significant event experienced in recent years taking place on 28th July 2014. During this event a very large storm reportedly led to the flooding of in excess of 10 properties. The majority of the flooding was centred around two areas in the town, to the north and east, roughly corresponding with the area demonstrated in Figure 2. In the north of the town the source of flooding was from the ordinary watercourse running from north to south, whilst in the east of the town the source was reportedly runoff from the fields. Anecdotal evidence from residents suggested that in some locations floodwaters reached in excess of 20-30cm within residential properties and caused substantial damage, resulting in some residents requiring temporary alternative accommodation.

An approximate indication of the flooded areas based on reports from residents, Thaxted Parish Council and partner authorities is shown in Figure 3. Photos from the event are shown in Appendix A.

Figure 3 – Indicative flood area during the events [Not to be used as indication of individual properties experiencing internal flooding]. (Base Map: Ordnance Survey, 2014).

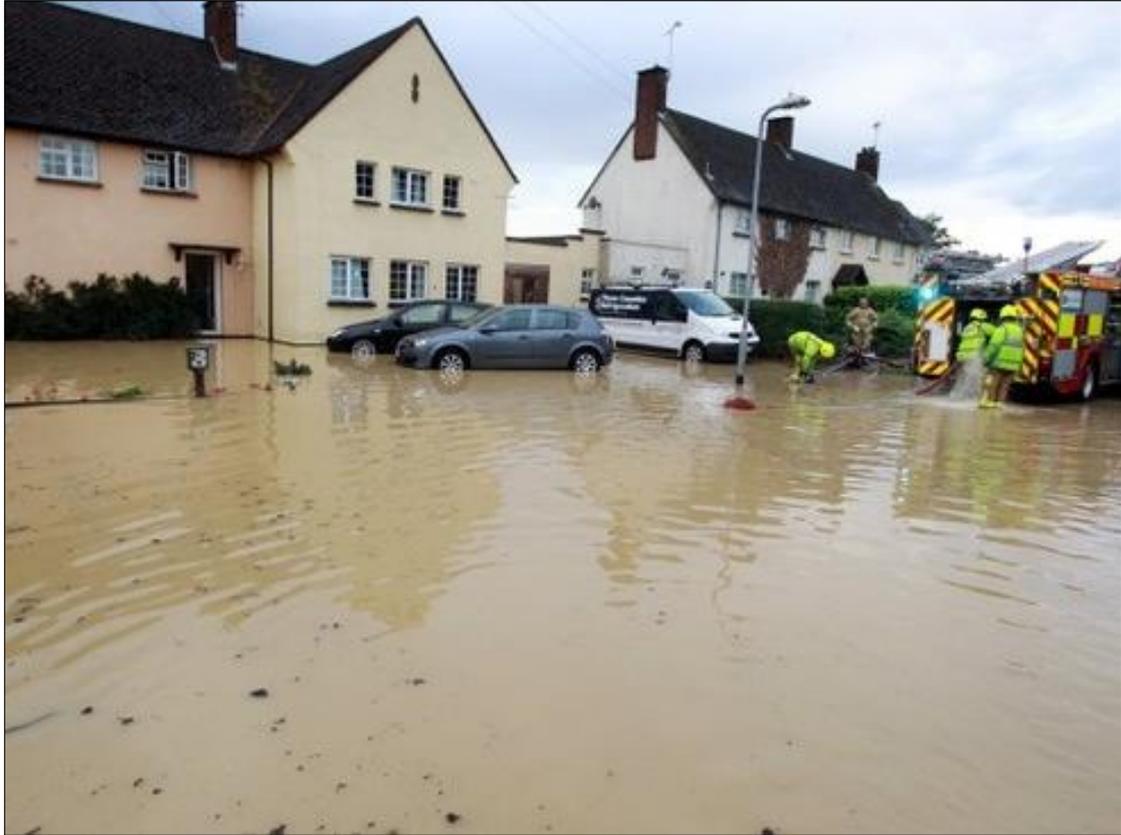
Figure A1 (Above) – Flooding in Thaxted on 28th July 2014 (Stephen Huntley, 2014)

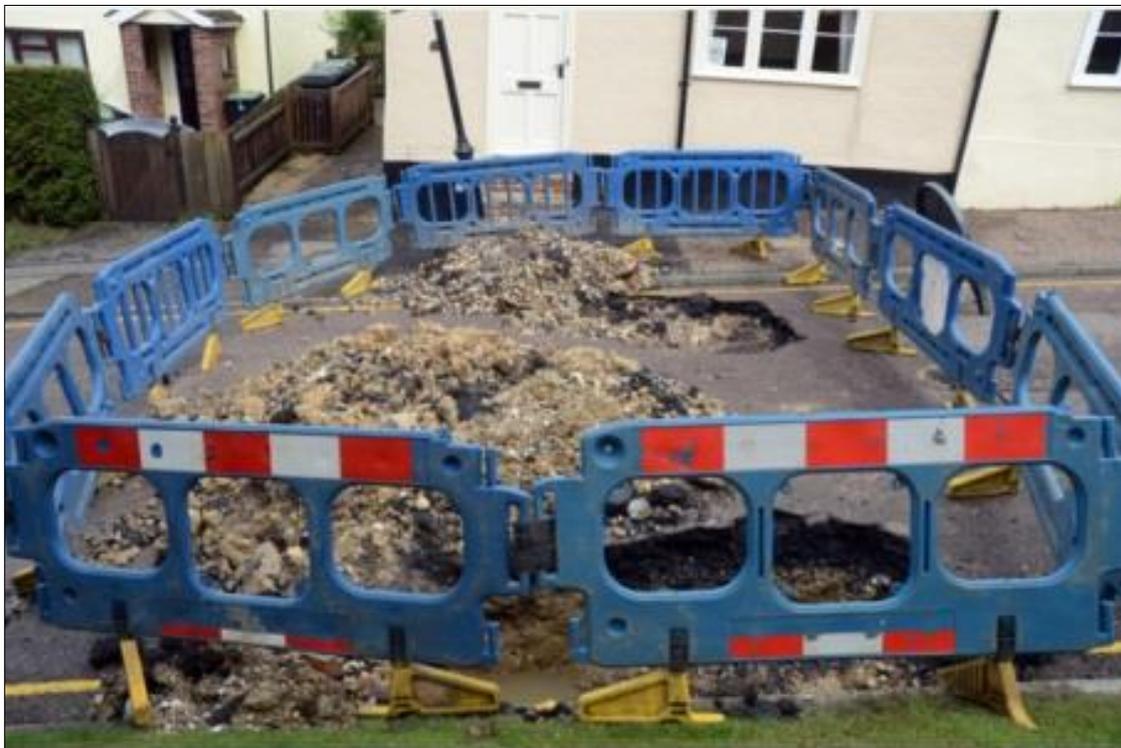
Figure A2 – Damage caused by flooding to Bolford Street (Vikki Lince, 2014).

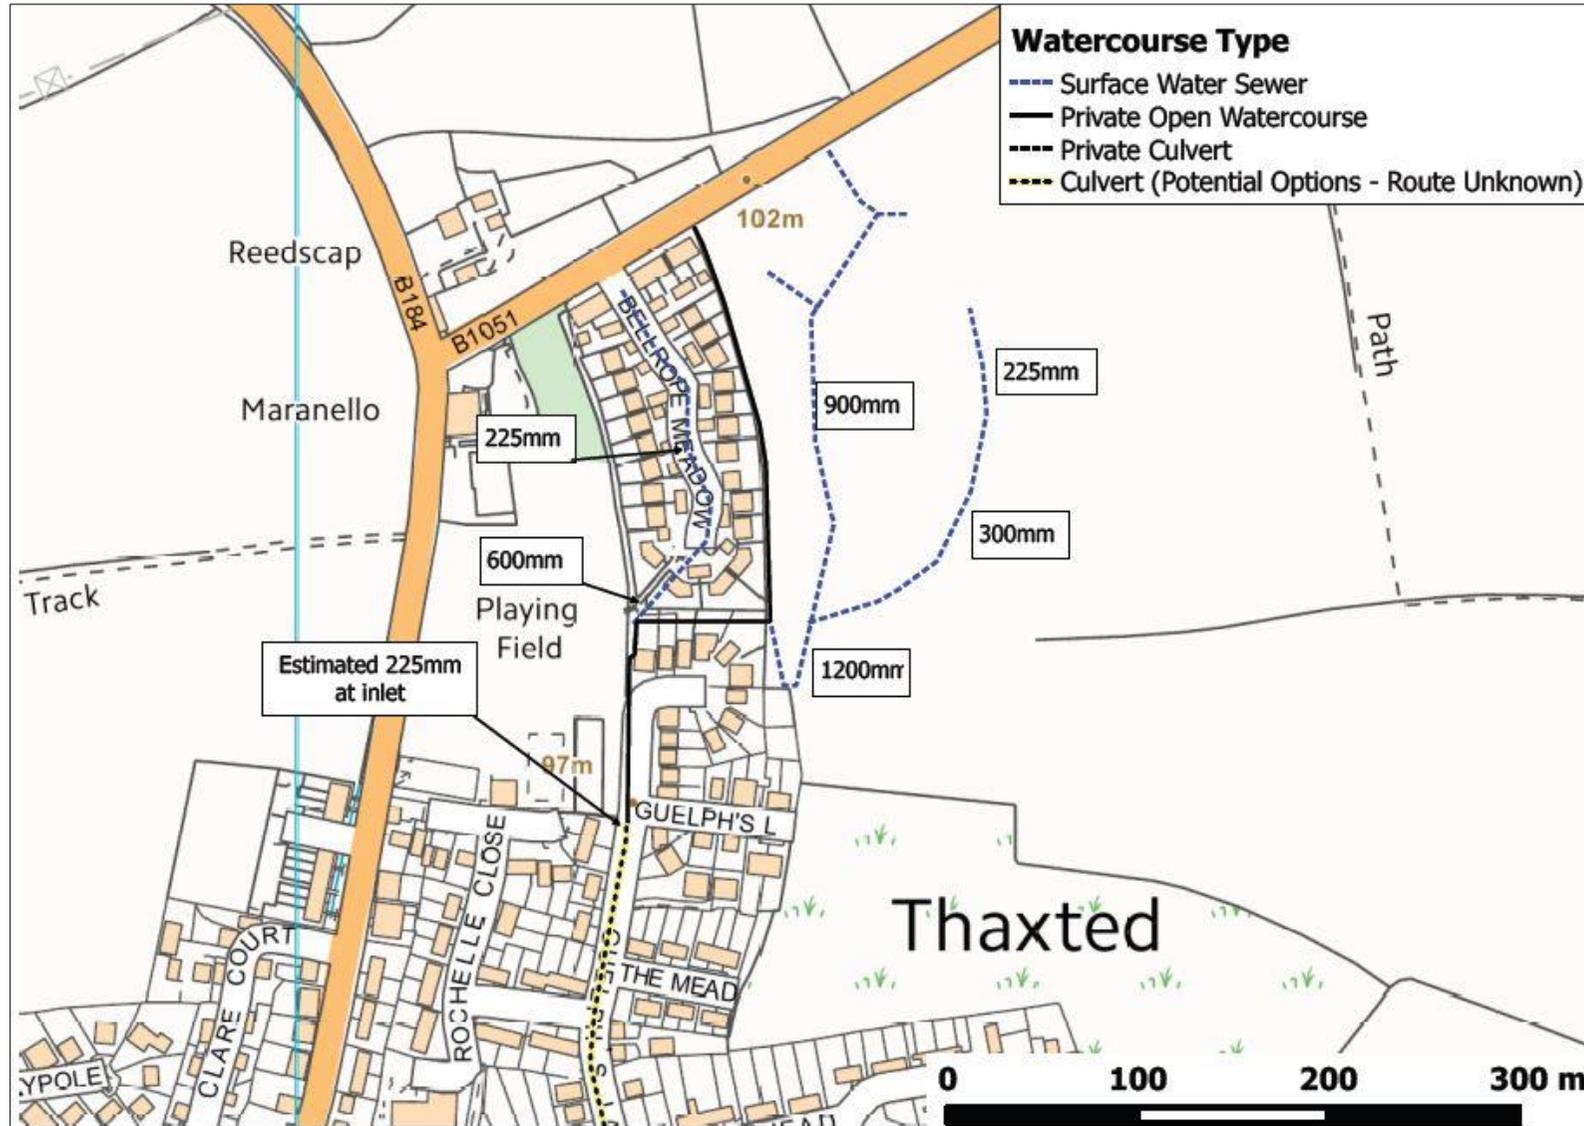
The current condition and capacity of the drainage system, particularly the sections of culvert which are privately owned, is relatively unknown. Whilst it is unlikely given the volume of rainfall that a blockage or constriction in any one section of culvert was the primary factor in this flood event, if investigation determines that any such problems exist they could be exacerbating the flood risk in the local area. As such, it is recommended that further investigation is undertaken, in particular an assessment of the condition, route and capacity of the culvert shown as unknown in Figure 4 and Figure B1 (Appendix B).

Figure B1 – North Thaxted Drainage Network. Data from digdat.co.uk, site observations and estimated culvert routes based on natural drainage paths (Pipe diameter indicated where available).

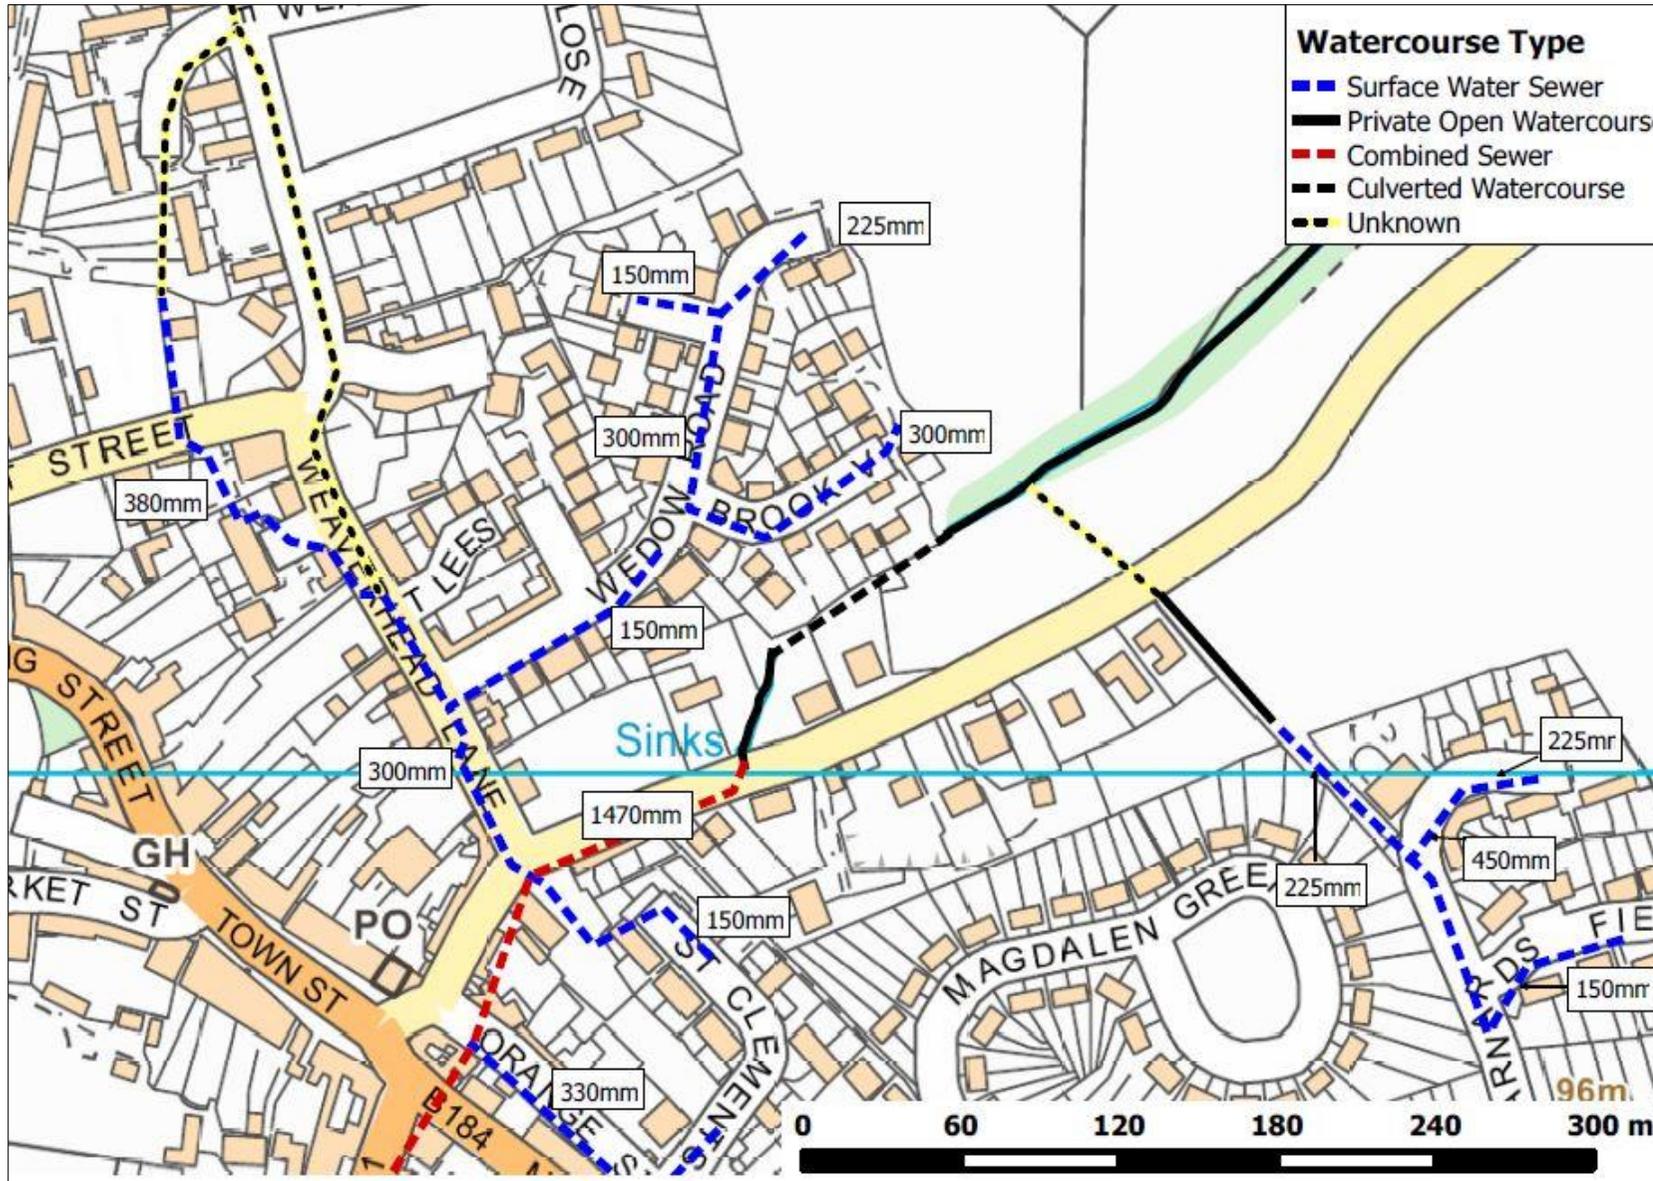
Figure B2 – Central Thaxted Drainage Network. Data from digdat.co.uk, site observations and estimated culvert routes based on natural drainage paths (Pipe diameter indicated where available).

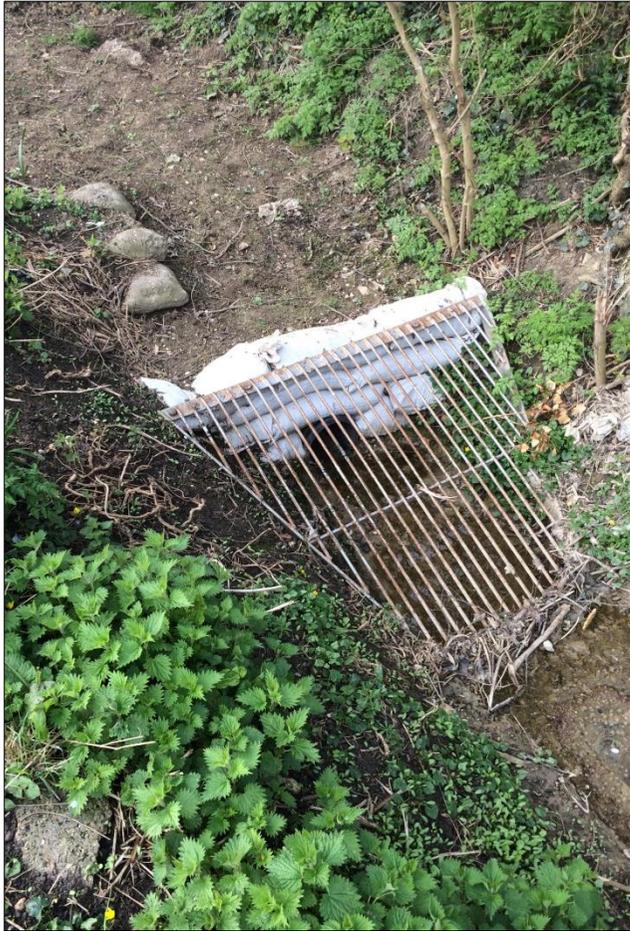
There are several key locations where blockages in culverts would have caused issues, in particular in the section of culvert alongside Guelph's Lane, which takes a substantial amount of water from the upstream watercourse. Whilst the sewer discharging into the open watercourse upstream is shown to be 600mm diameter on Figure B1 in Appendix B, the inlet of the culvert on Guelph's lane is estimated to be approximately 225-300mm in diameter. As such this would cause a substantial constriction on the system, and is particularly important that it is kept clear and free running. It is therefore recommended that a CCTV survey be undertaken to establish the condition, route and capacity of the culvert with a view to considering any options for improvement/maintenance accordingly.

Figure C1 – Culvert inlet on Guelph's Lane (from north)

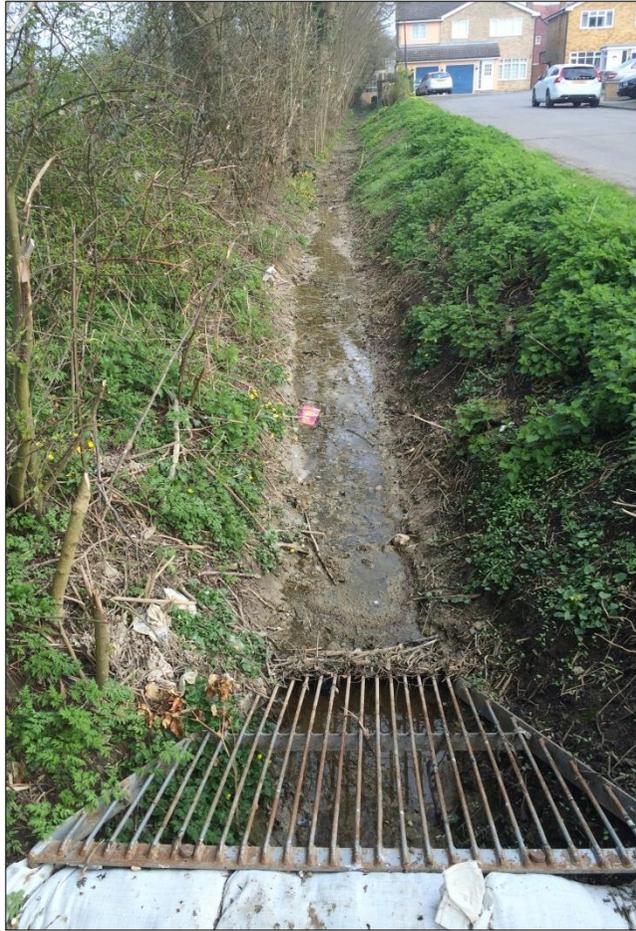
Figure C2 – Culvert inlet on Guelph's Lane (from south)

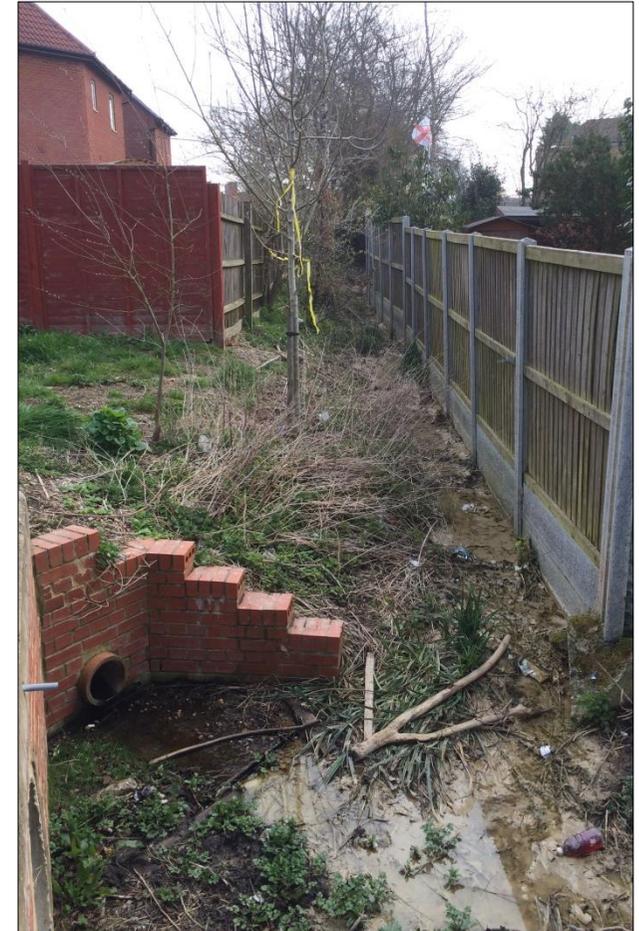
During initial inspection a number of sections of open watercourse were found to be in relatively poor condition, with overgrown vegetation, leaf litter and substantial levels of silt reducing the capacity of the watercourse running alongside Guelph's Lane to the north end of the town. During subsequent inspection the other major watercourse sections were found to be in reasonable condition and since the initial inspection the north section of watercourse has been cleared (Figure C2, Appendix C), although there is evidence of significant volumes of silt entering the watercourse (shown in Figure C3, Appendix C) which has the potential to cause problems if not properly controlled.

Figure C3 – Watercourse south of Bellrope Meadows
